Manhole Inspection Summary

Manhole # S29II1009MH

Insp Date: **4/16/07 10:37 AM**

Location Address: **4204 WICKFORD RD**

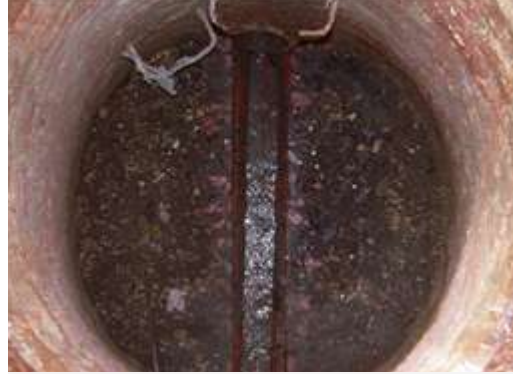
Top View

Bench ☒ Exists Material: **Brick** ☐ Parged ☒ **Debris** (not Condition related)

Steps Count: **2** Missing: **1** ☒ **Corroded**

Surcharge ☒ **Evidence Of Surcharge** Depth: **3** (ft.) ☐ Active Surcharge Present

Corroded and missing steps. Evidence of surcharge - Bench debris.

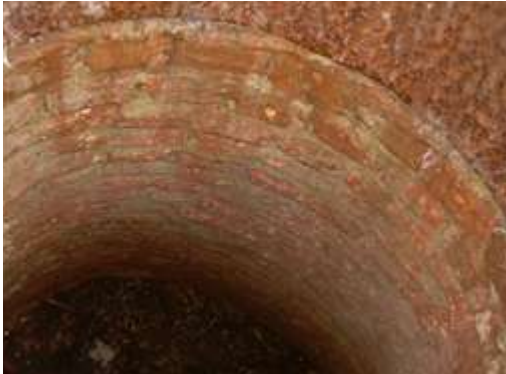
Defect

Condition: ☐ Sound ☐ Cracked ☐ Root Intrusion ☐ Loose Brick ☒ **Deteriorated**

Infiltration: ☐ None ☒ **Joint** ☐ Cracks ☐ Mortar ☐ Roots ☐ Wall

Infiltration: ☐ None ☐ Joint ☐ Cracks ☒ **Mortar** ☐ Roots ☒ **Wall**

Corbel deterioration and infiltration. Barrel infiltration.

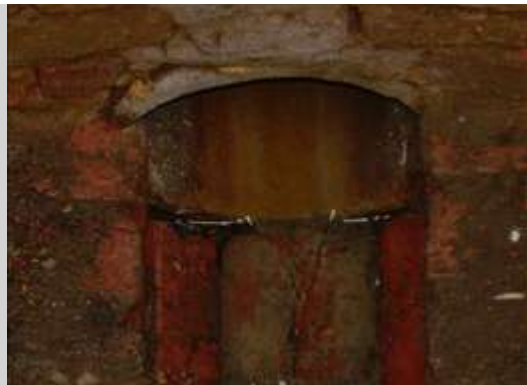
Pipe In @ 5 O'Clock

Infiltration: **Evidence** Pipe Seal Cond: **Cracked**
